#### OPEN SEA, SURFACE EVALUATION OF SUBMARINE ESCAPE

# AND IMMERSION EQUIPMENT

# SUBMARINE MEDICAL RESEARCH LABORATORY NAVAL SUBMARINE MEDICAL CENTER REPORT NO. 614

Bureau of Medicine and Surgery, Navy Department Research Work Unit MF12.524.006-9025B.34

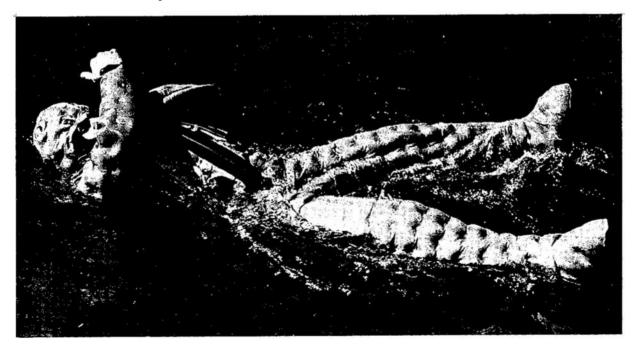
Fig. 3: Subject floating in a completely inflated Mark VII suit.

When the Mark VII suit was inflated by the CO2 system to design shape, the subject was automatically floated on his back in the manner shown in Figure 3. In a smooth sea with less than one foot wave height and light winds (1-3 knots), the Mark VII appeared to float the subject in an almost completely horizontal, supine position. This attitude generally persisted through wave heights up to the four to five foot range with wind velocities up to 20 knots. The amount of buoyancy present in the CO2 inflated suit appeared adequate in that there was no observed tendency for the suit to get "out of phase" with the waves in choppy seas. If the amount of buoyancy in the suit was not adequate, then in choppy seas it could be anticipated that the subject would fail to rise to the top of each wave, and consequently would be repeatedly 'ducked'. No such tendency in the Mark VII was noted in the sea conditions encountered during the trials. The suited subject appeared to drift on the sea surface as a relatively rigid unit rather than as a sectional, undulating unit.

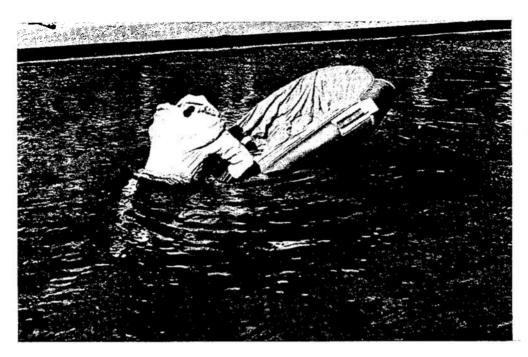
Fig. 5: One-man life raft being boarded by a man wearing the ACED HISR suit.

With respect to the HISR suit and raft, it can be said that some difficulty was experienced by the subjects in boarding the one-man life raft once it was inflated. The degree of difficulty seemed to increase as the sea state increased. The subjects also experienced some difficulty in erecting the collapsed canopy. This probably was due to the manner in which it had been folded for packing. Once erected no difficulty was experienced in the inflation of the canopy. The next part of the evolution involved the bailing of the water from the raft. The usual depth of water in the rafts was approximately eight inches. With the small collapsible cup provided with the raft, and having to pour the water out through a tube in the

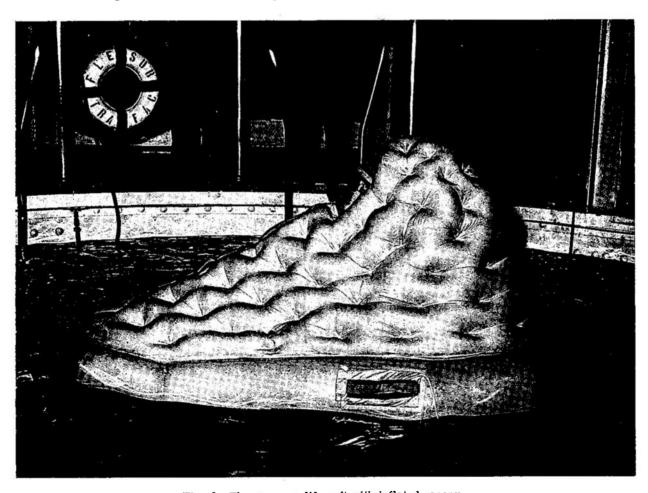
Fig. 6: The one-man life raft with inflated canopy.

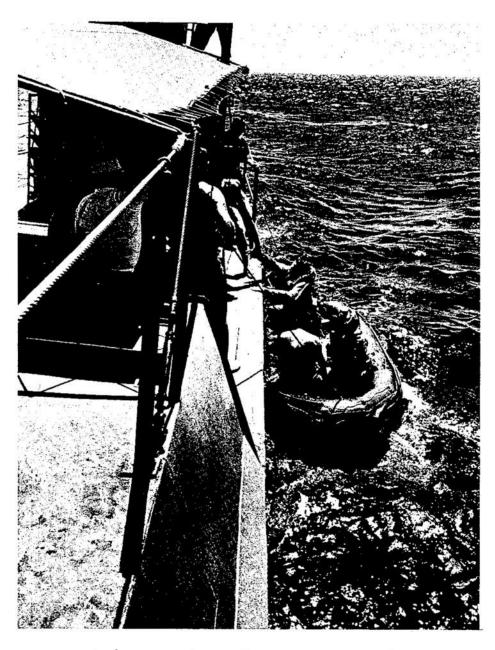
Fig. 9: Subjects being brought back aboard support craft.
